Deal Island Shoreline Focus Area Factsheet

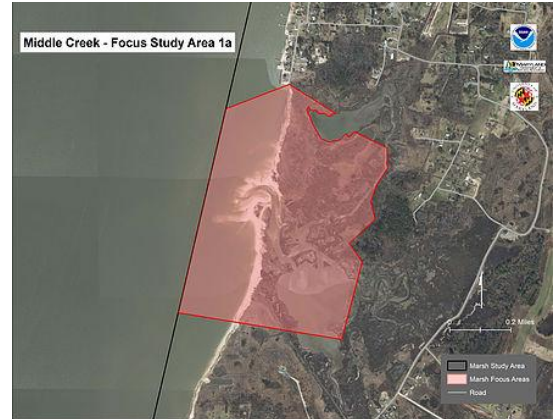
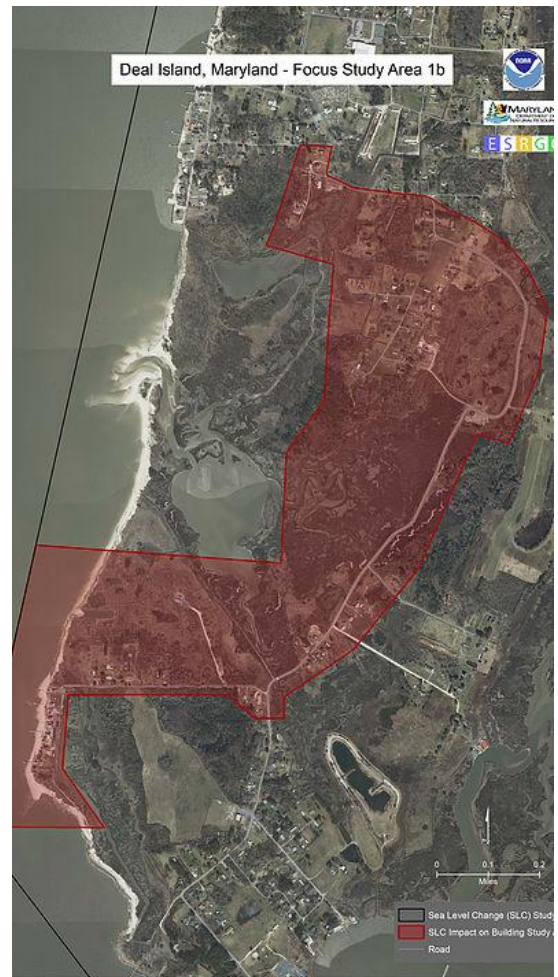
Top row: Deal Island shoreline beach erosion with ghost forest in background, photo taken from Crowell Rd.;
Bottom row: damaged bulkhead and riprap on Tangier Sound shoreline with signs of erosion (Photo Credit: L. Collier).

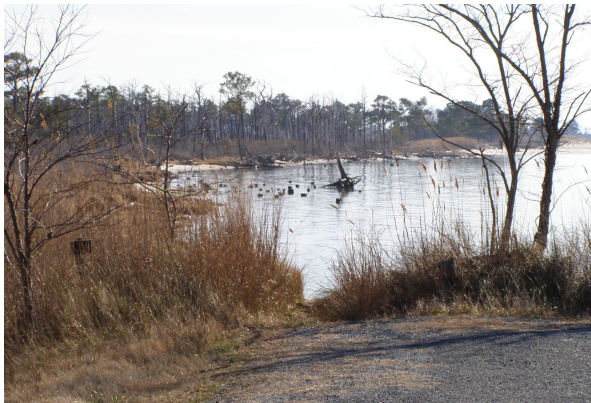
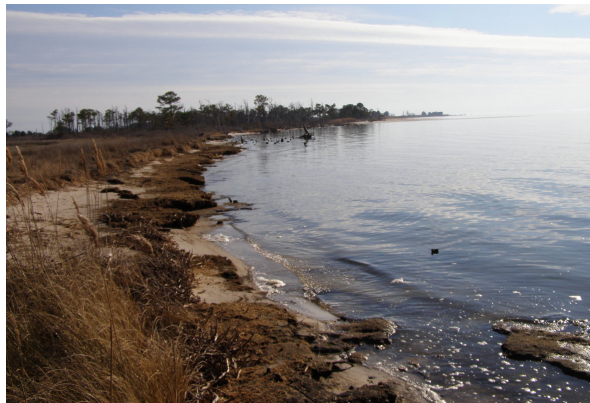
- ***Deal Island Shoreline at Crowell Road:*** Significant erosion is occurring along this shoreline, which once had substantial dune structures that provided critical barriers during storm events. The forest area on backside of the shoreline is also dying due to saltwater intrusion. In several locations, the Tangier Sound is on the verge of breaking through to the tidal marsh in the Middle Creek Marsh area, which would increase wave action and erosion rates to interior sections of Deal Island, with potentially severe impacts for the Ballard Road community, a historic church, and Deal Island Road.

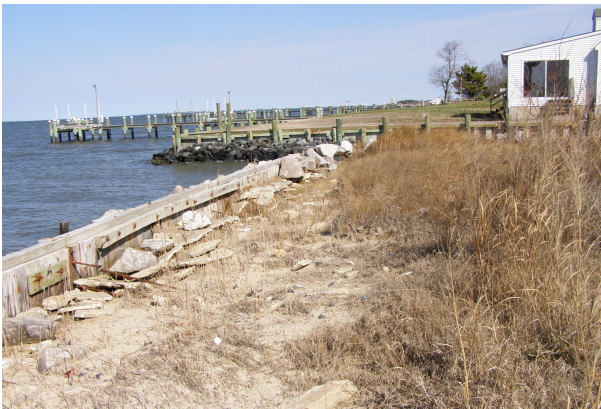
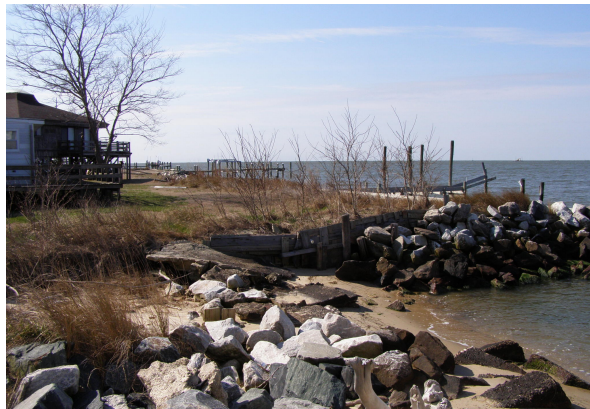
- **Shoreline vulnerabilities:** 23% of property owners have bulkhead, 46% have riprap, and 54% have natural shoreline. Only 15% of those with bulkhead said it is in good condition; 23% of those with riprap said their riprap is in good condition. No data reported on natural shoreline conditions.

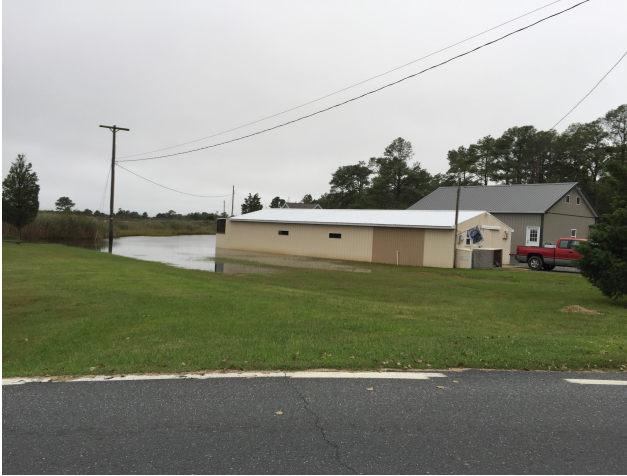
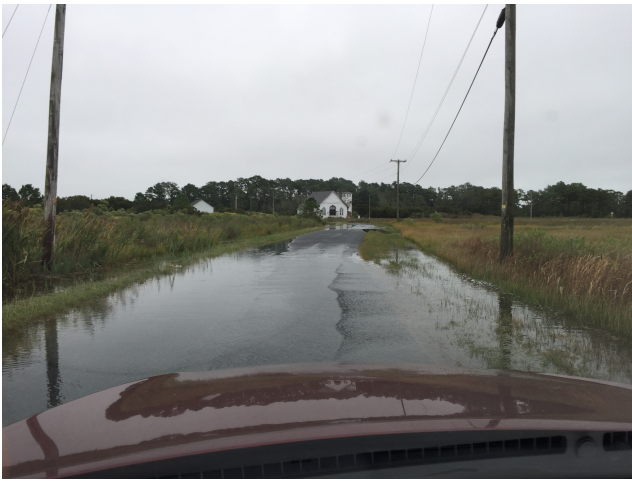
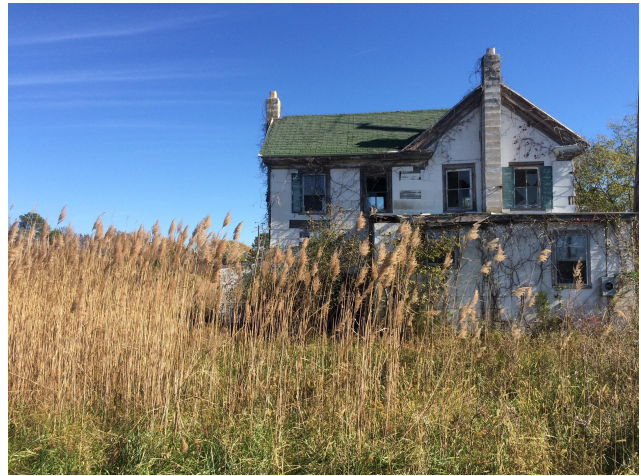
- ***Ballard Road Neighborhood:*** This historic African American neighborhood is located behind the Middle Creek marsh area, and is prone to roadway flooding along the only access road to the community during storm events. Much of this area is also low lying, and therefore many residents are also experiencing marsh encroachment and are vulnerable to flooding during storm events.

- **Deal Island Road Adjacent to Middle Creek Marsh Areas:** While this section of the Deal Island Road does not currently experience roadway flooding, it is highly vulnerable to future flooding should the Deal Island Shoreline breach. It also provides the only access point to Wenona, an important commercial harbor for the area. Also located along this road is John Wesley UMC, which would likely be impacted by increased exposure from shoreline breach.
- **Deal Island Road Near Intersection with Ford Road:** The culverts underneath this road were recently replaced, thereby allowing additional water to pond on the north side of the road, particularly towards Osbourne Webster Road. There is a concern about installing proper flood gates that would allow water to drain, ameliorating flooding to nearby properties via ditches.

Top left: Flooding along Deal Island Rd. at Ford Rd. following a tropical storm during Fall 2016. Flooded shed is part of a commercial watermen business. Visible behind the shed is the Middle Creek marsh area (photo credit: M. Paolisso). **Right:** Abandoned property in Ballard Rd. neighborhood with marsh encroachment (photo credit: E. Van Dolah). **Bottom left:** Flooding during a storm on Ballard Rd. heading east towards Deal Island Road and John Wesley UMC. Middle Creek marsh is pictured on the right (photo credit: M. Paolisso).

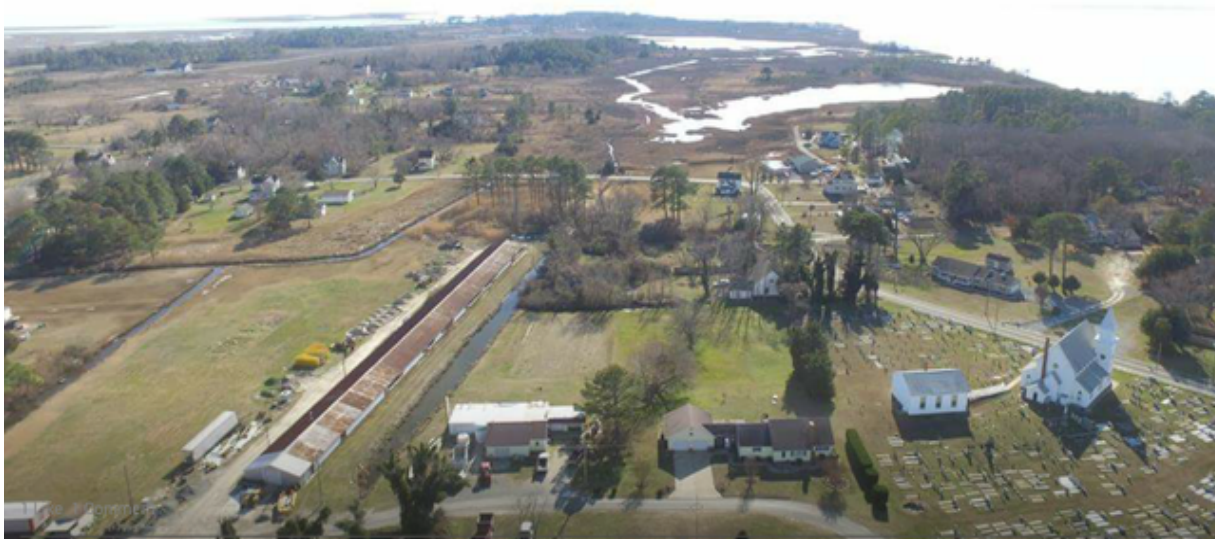
Above: Aerial of Focus Area, looking southwest. St. John's UMC and Deal Island Rd. can be seen in lower right, and Middle Creek Marsh in top center. John Wesley UMC is in top left. (photo credit: C. Collier).
